**GOVERNMENT OF INDIA  
MINISTRY OF CIVIL AVIATION  
(COMMISSION OF RAILWAY SAFETY)**

**RAILWAY ACCIDENT INVESTIGATION  
REPORT**

**Derailment of 2301 Up Howrah - New Delhi Rajdhani  
Express train at km. 508/19-21 between Rafiganj and Deo  
Road stations on Gaya-Mughalsarai Grand Chord Double  
line Broad Gauge Electrified Section of Mughalsarai  
Division of Eastern Railway on 09-09-2002**

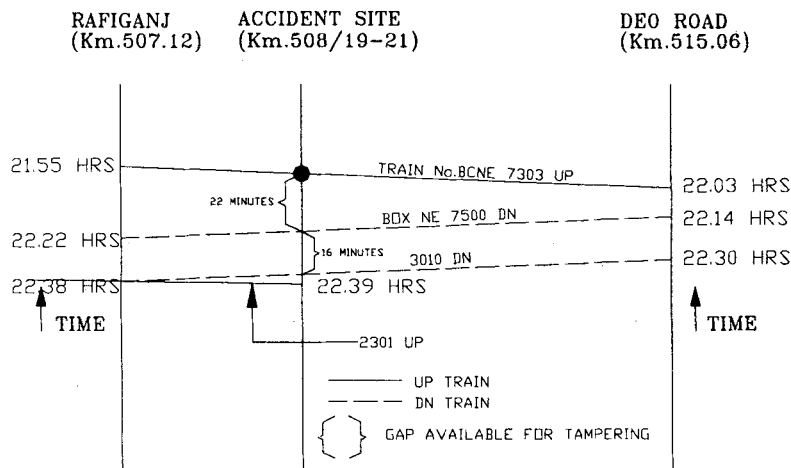
#### 7.3.9.9 Time available for the miscreants :-

- 7.3.9.10 The timings of the Up/Down trains which passed over the section Rafiganj to Deo Road just prior to the passage of the ill-fated train have been plotted in the above graph which shows that there were two gaps of approximately 22 and 16 minutes which were enough for tampering with the track. The PWI in his statement in para 5.2.10, stated that two rank outsiders (i.e. other than permanent way men) could open fish plates of both joints and all ERC clips of the 9.01 m rail in 15 minutes. I also feel that this tampering can be finished in less than 15 minutes - whereas the miscreants got two long gaps of 22 and 16 minutes. In addition to this, near the bridge there is an abandoned building on the cess side of Up line which might have provided a good cover for the miscreants to hide whenever a train must be approaching.

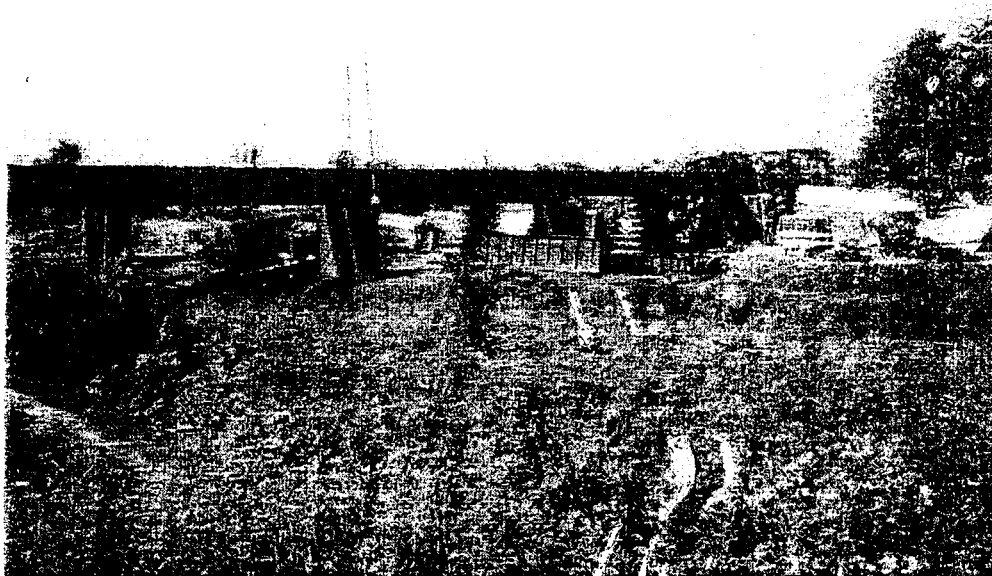
**Bridge No. 445 near Rafiganj on Mughalsarai division**

- 1.1 In the night of 09.09.2002, 2301UP Sealdah-New Delhi Rajdhani Express met with an accident at 2242 hrs near Bridge No. 445 at Km 508/19-21 between Rafiganj-Deo Road stations of Eastern Railway. Keeping in view the severity of the accident, CRS Eastern Circle initiated the inquiry to find the cause of accident of this train. Meanwhile, Railway Board asked RDSO to examine the Bridge. On the following date, CCRS also instructed RDSO to conduct various types of testing so as to assess the strength of the bridge and thereafter submit the report.

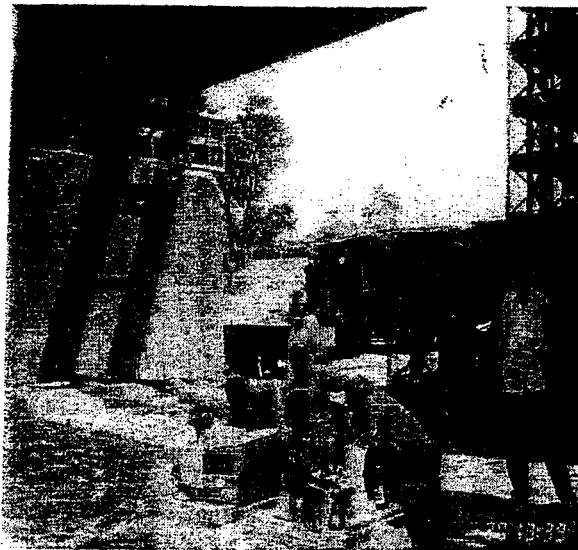
AE monitoring of bridge pier

8.1.1 Acoustic emissions are defined as the high frequency stress waves generated by the rapid release of strain energy that occurs within a material during crack growth, plastic deformation or phase transformation. This energy may originate from stored elastic energy as in crack propagation or from stored chemical free energy as in phase transformation. The location of crack/flaws in side the structure can be detected from this technique. It can also detect the activeness and severity of crack.

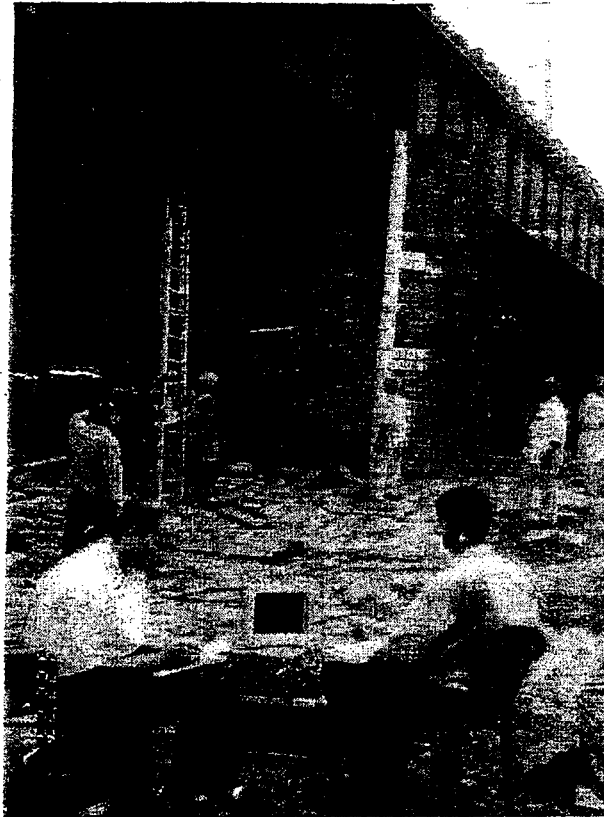
Monitoring of pier with Impulse radar

- 8.6.2 Discussion were held with the experts in the field of NDT's about the use of this equipment for investigation of brick masonry. Based on their guidance, observations were taken on all the piers (Ann-X). The display and line scan survey with GPR on each pier is almost similar on masonry structure of all the piers which indicate that affected and unaffected portions of piers are almost similar. Uniformity in results shows similar strength as well as absence of any cracks.
